NBSIR 79-1597

Examination of Components from a Mahler-Weber PJ-260 Aircraft

Failure Analysis Report

September 1978
Issued January 1979

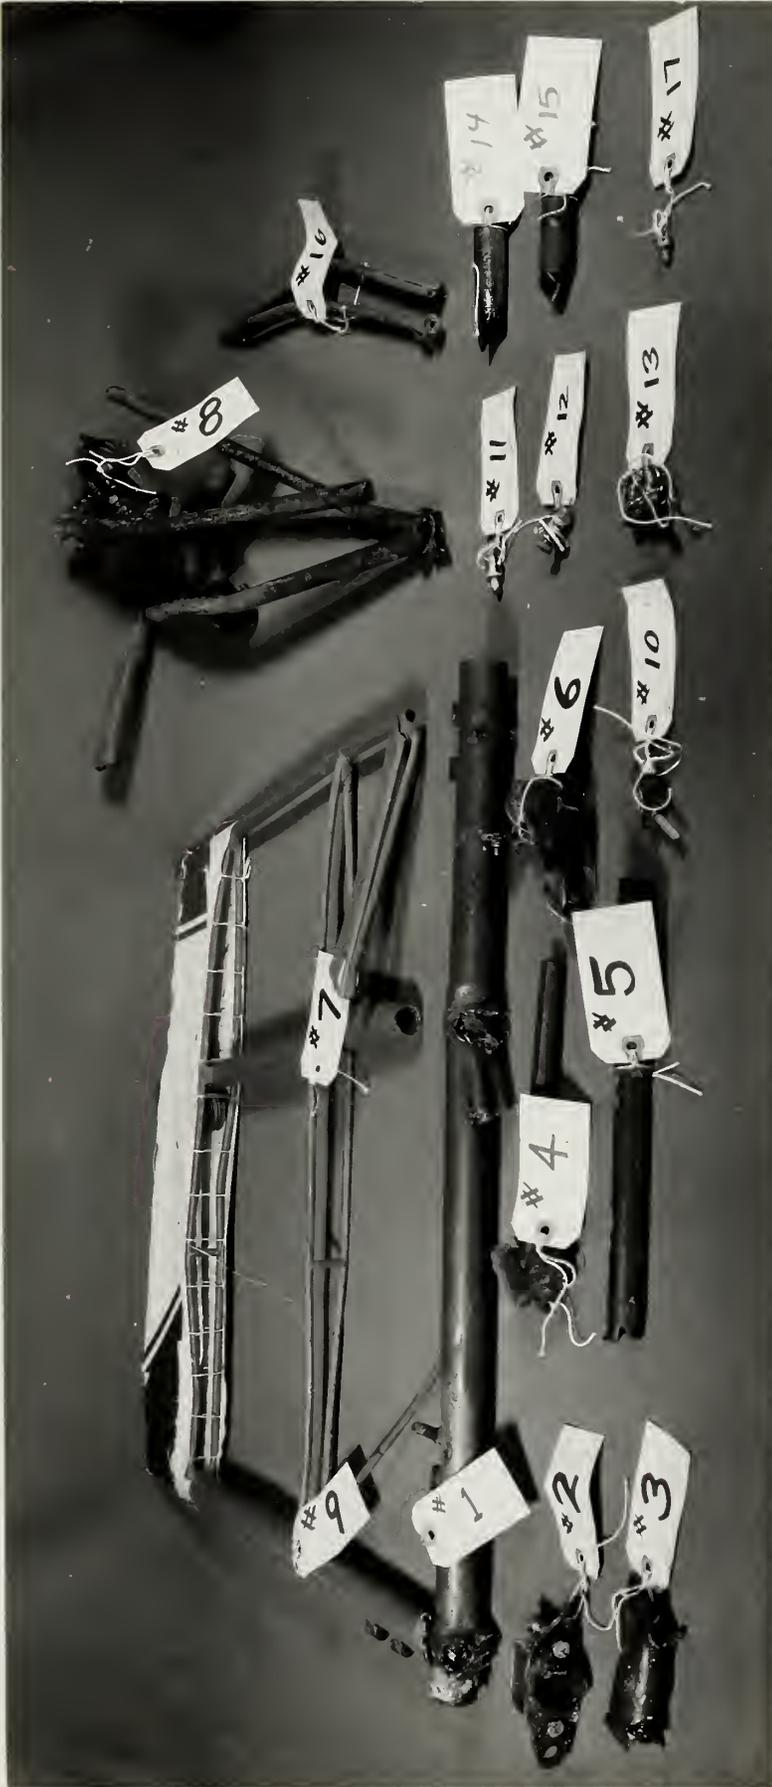
The parts are shown as received at NBS in figure 1.

Figure 1. Parts of the Mahler-Weber PJ-260 aircraft as received. X 1/5
